RESOLUTION 2015-08-02

A RESOLUTION OF THE DOWNTOWN INVESTMENT AUTHORITY (“DIA”) APPROVING A SCOPE OF SERVICES, INCLUDED AS EXHIBIT ‘A’ TO THIS RESOLUTION, FOR THE PROCUREMENT OF PROFESSIONAL SERVICES RELATING TO DOWNTOWN LIGHTING IMPROVEMENTS. AUTHORIZING THE DIA CHIEF EXECUTIVE OFFICER TO NEGOTIATE AND EXECUTE CONTRACTS IN ACCORDANCE WITH THE SCOPE OF SERVICES.

DOWNTOWN LIGHTING STRATEGY AREA REQUEST FOR PROPOSAL

“Downtown Lighting Evaluation”

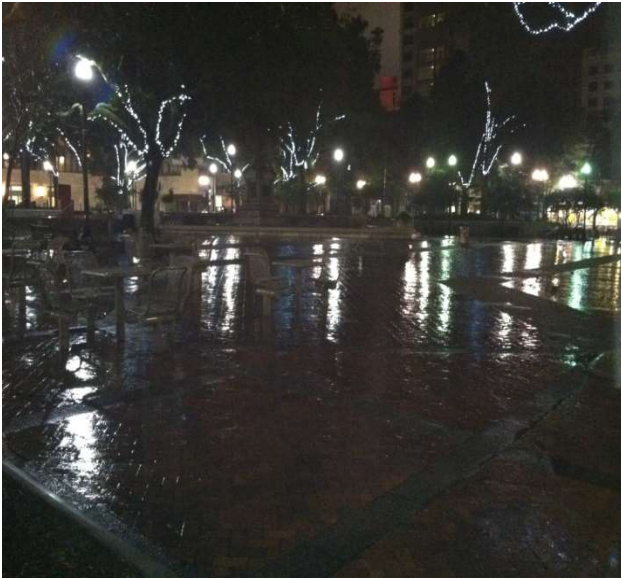
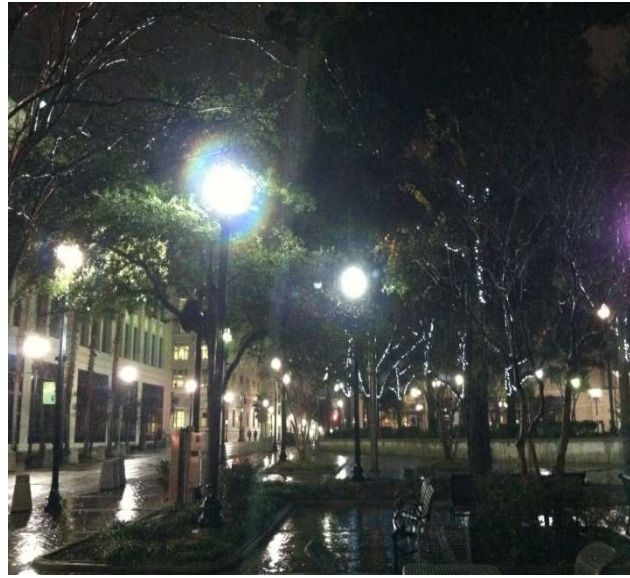
Area "A"

Area had a significant number of lights (almost to the point of being excessive). A vast majority of the lighting at this location was non-directional, and contained no protection from glare or light trespass / pollution.

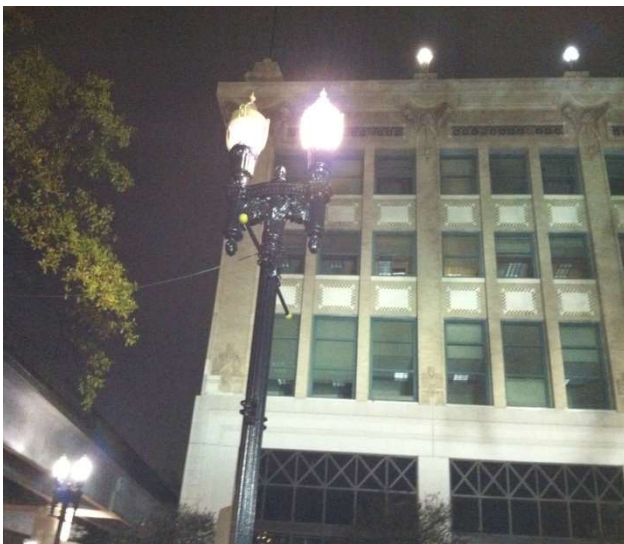
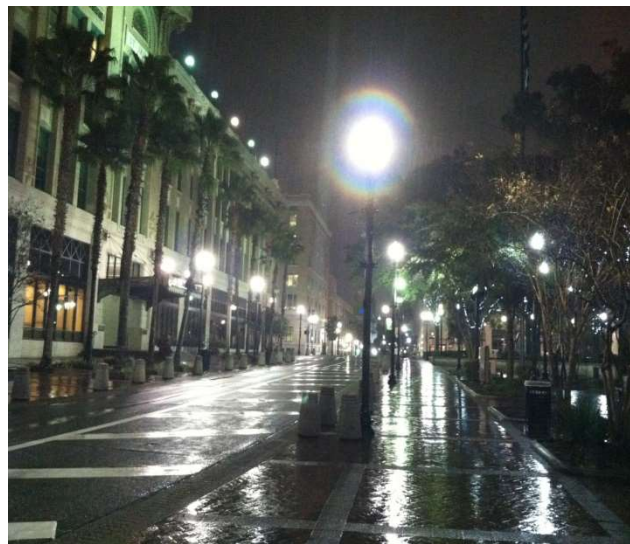
Some of the lighting fixtures appeared to be broken, and were not operational.

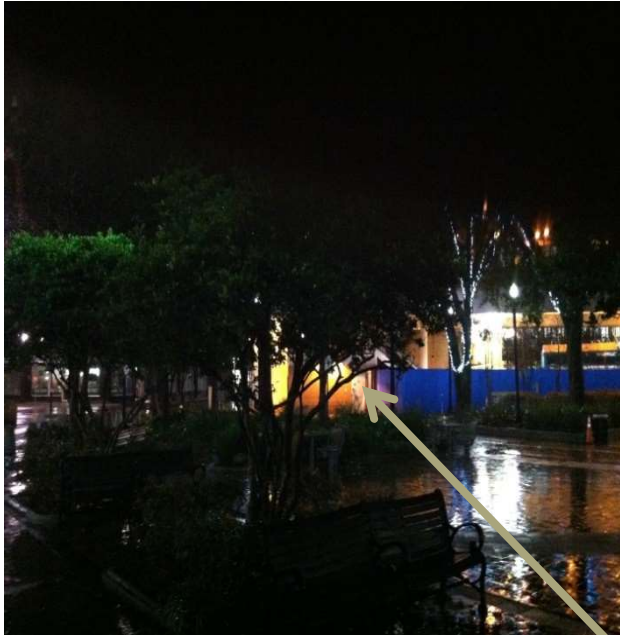
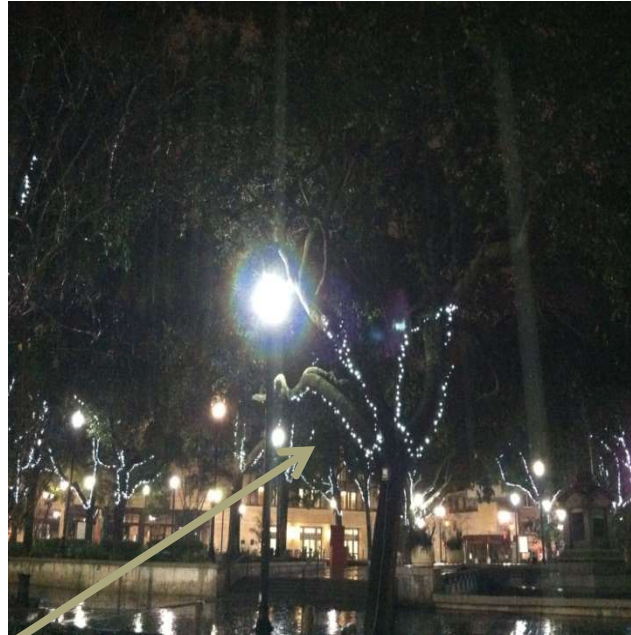
Area "A"

A large number of installed lighting (particularly in the Hemming plaza park area) were either obstructed, or fully concealed by existing vegetation. As a result, numerous concealment areas, and dark locations were created.

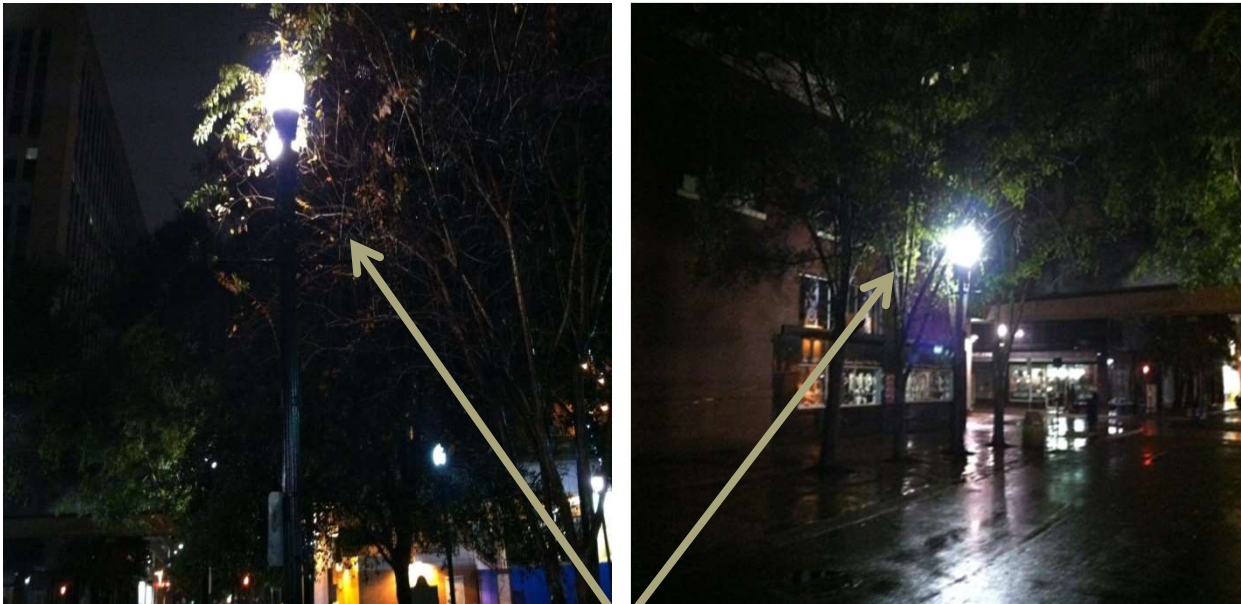
Area "A"

A large number of installed lighting (particularly in the Hemming plaza park area) were either obstructed, or fully concealed by existing vegetation. As a result, numerous concealment areas, and dark locations were created.

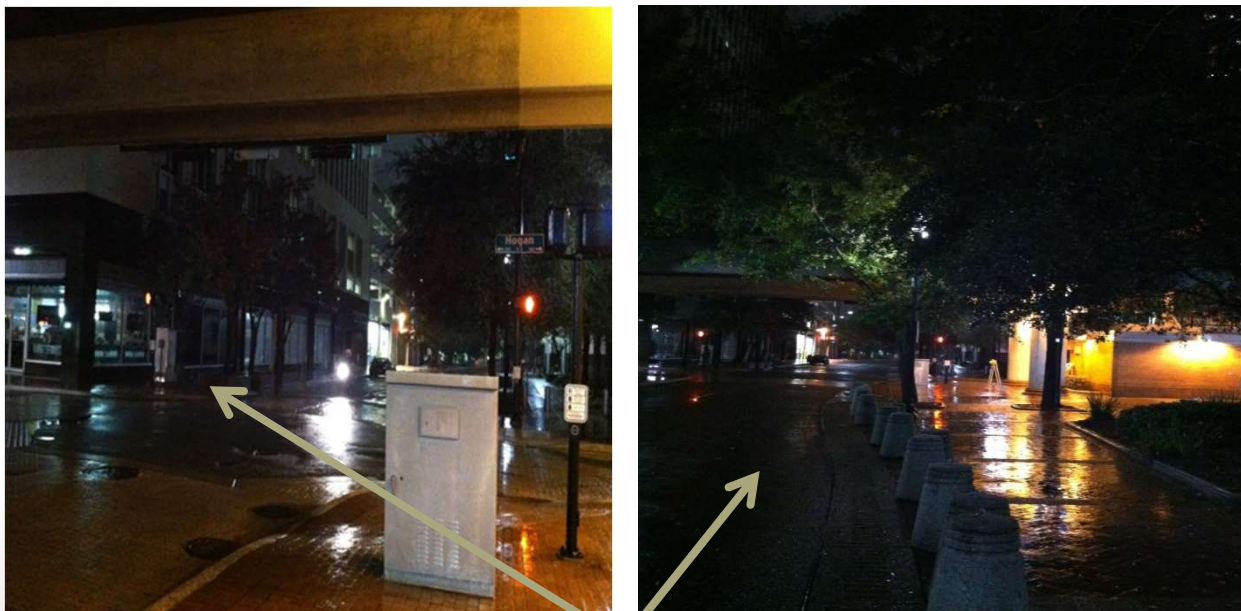
Although the lights bordering the park were sufficient, nearby streets lacked sufficient lighting. It is recommended that additional (non-sodium) lighting be installed.

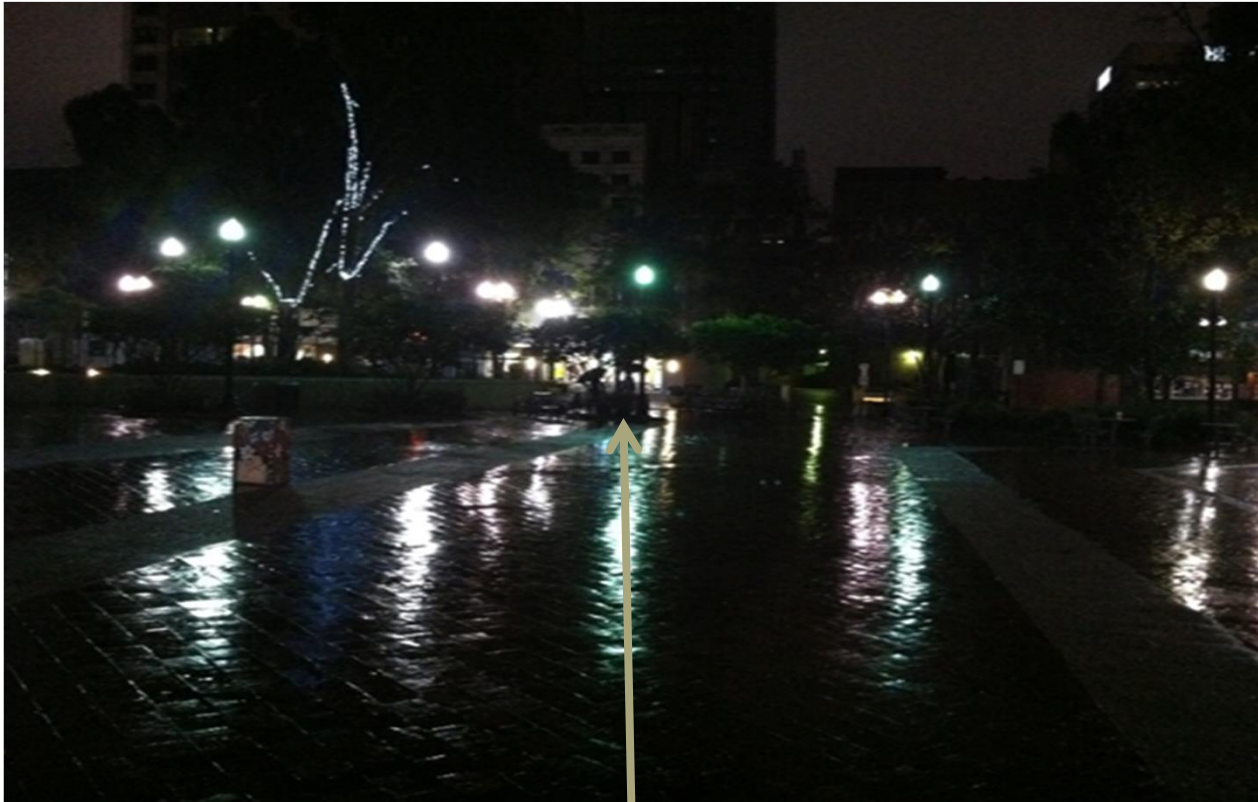
Area “A”

Although there is uniformity of lighting along the park’s perimeter, the wattage of those fixtures only emit a minimal amount of foot candles (fc) at ground level. The overall lighting plan provides a sufficient number of light fixtures to the areas outer border, but fails to appropriately address the park’s interior. In turn, this creates a lighting plan that only provides “silhouette” lighting (the least desirable of all lighting schemes). As a result, safety is compromised due to lack of clear visibility and illumination, and increases the overall fear of crime.

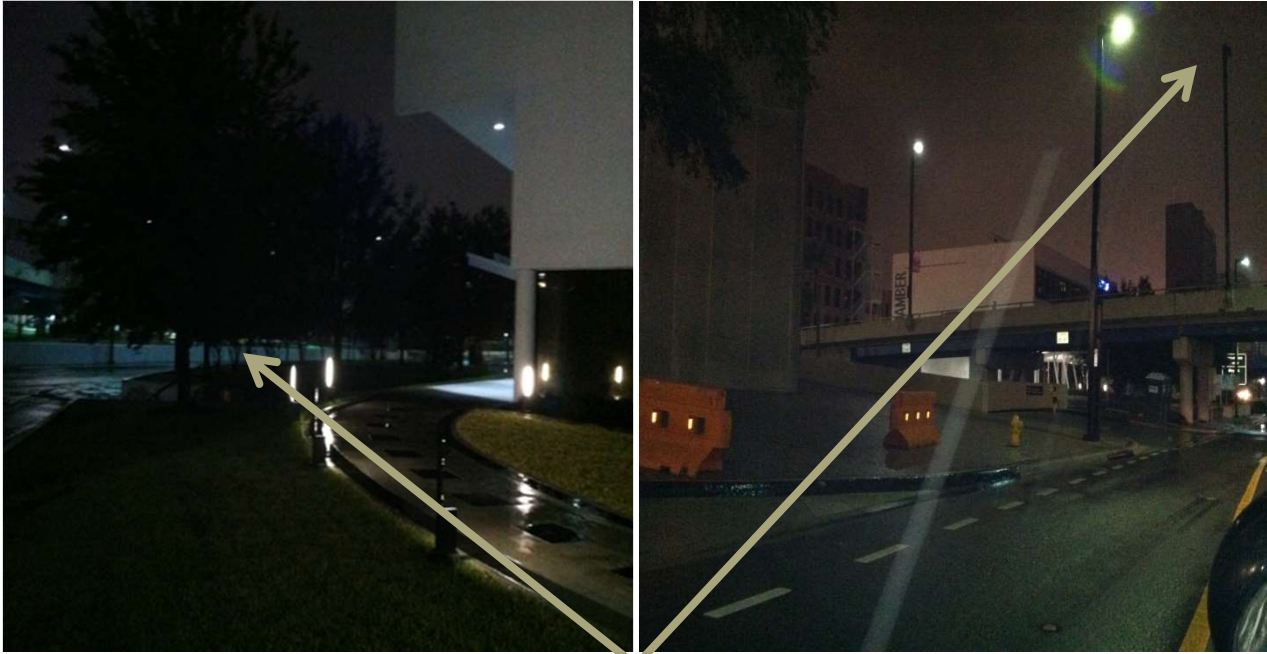
Area "B"

Numerous locations along the evaluated area contained dark locations, and/or inoperable light fixtures.

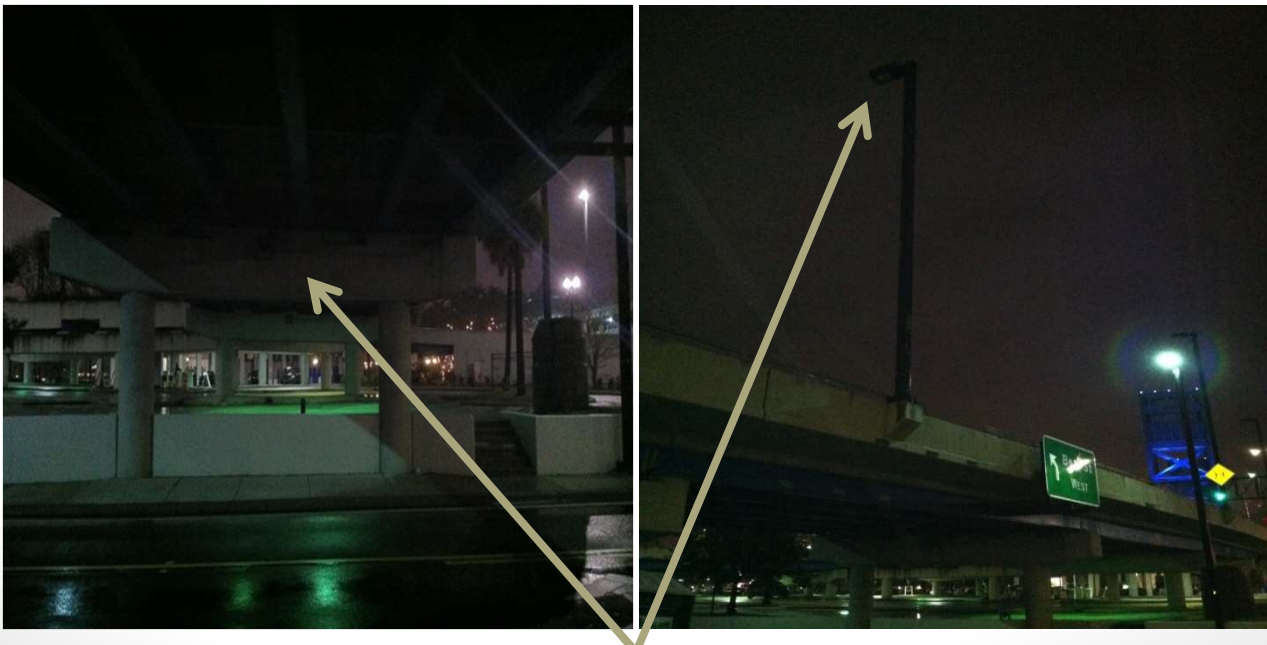
Numerous locations along the evaluated area contained dark locations, and/or inoperable light fixtures.

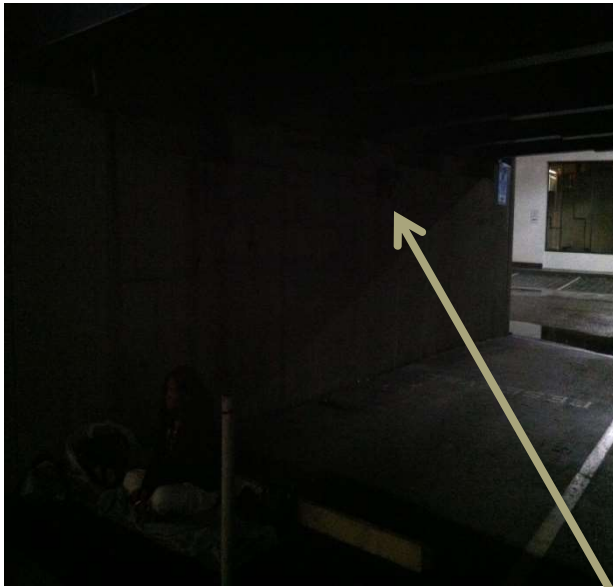
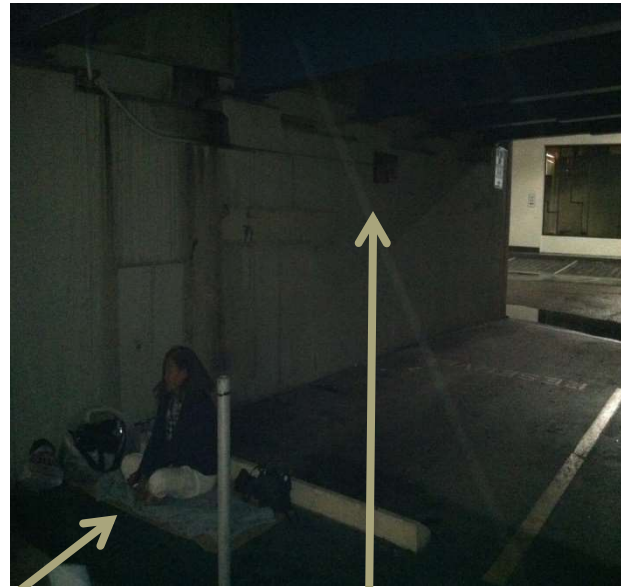
Area "B"

Numerous locations along the evaluated area contained dark locations, and/or inoperable light fixtures. Locations that provide concealment and minimal lighting were being utilized by unauthorized individuals which further diminish the feeling of safety.

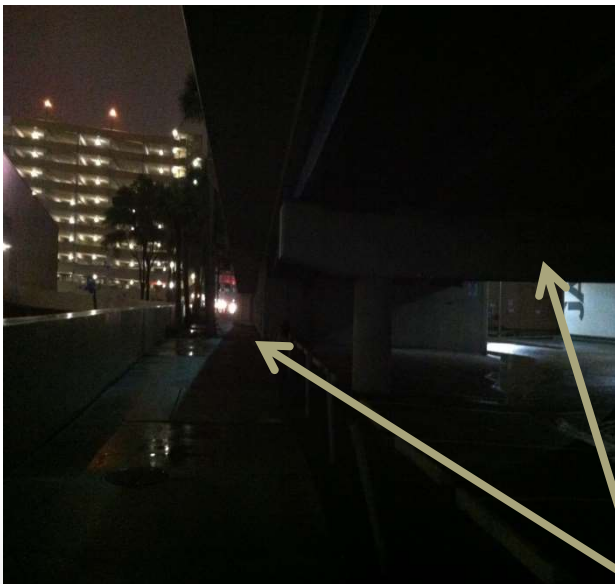
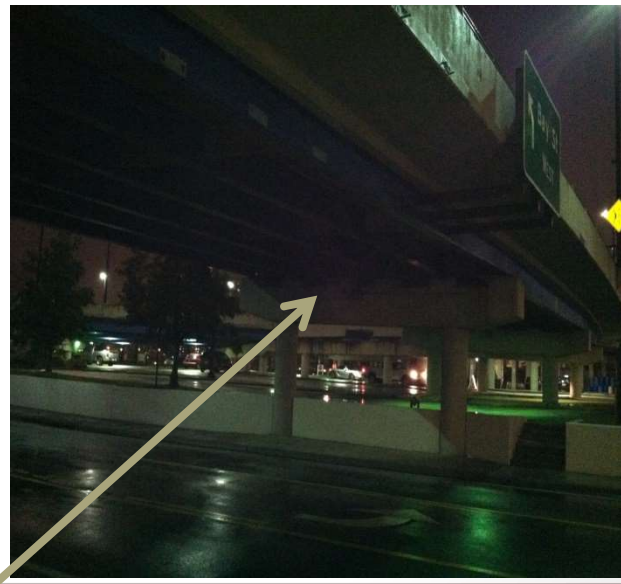
In addition to broken light fixtures, Poorly lit design features also contributed to the lack of available surveillance and fear of crime.

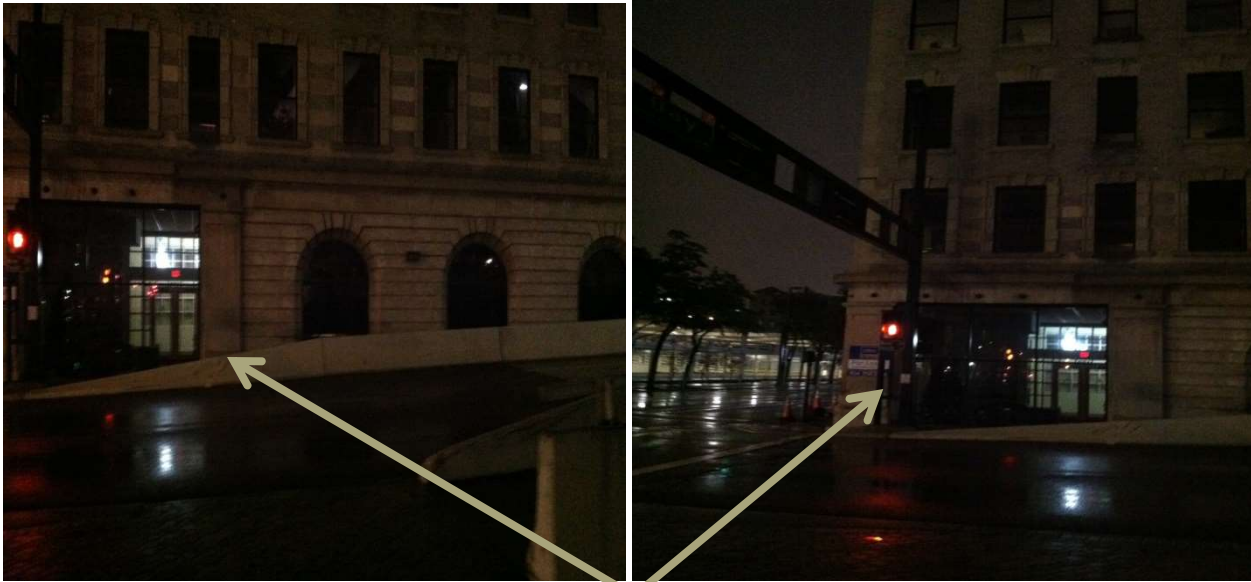
Area "B"

In addition to broken light fixtures, Poorly lit design features also contributed to the lack of available surveillance and fear of crime.

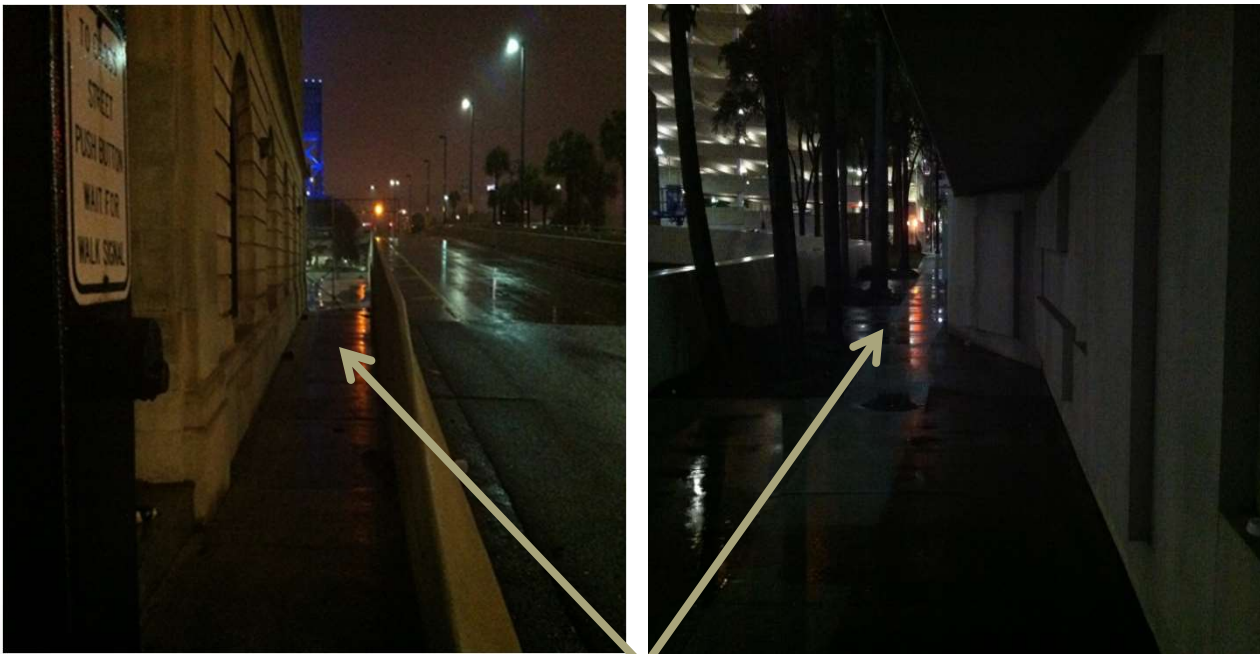
Broken light fixtures, and poorly lit areas contribute to the lack of available surveillance and increase the users fear of crime. It is recommended that either access to these areas be restricted, or additional lighting be placed along the walkway to increase visibility.

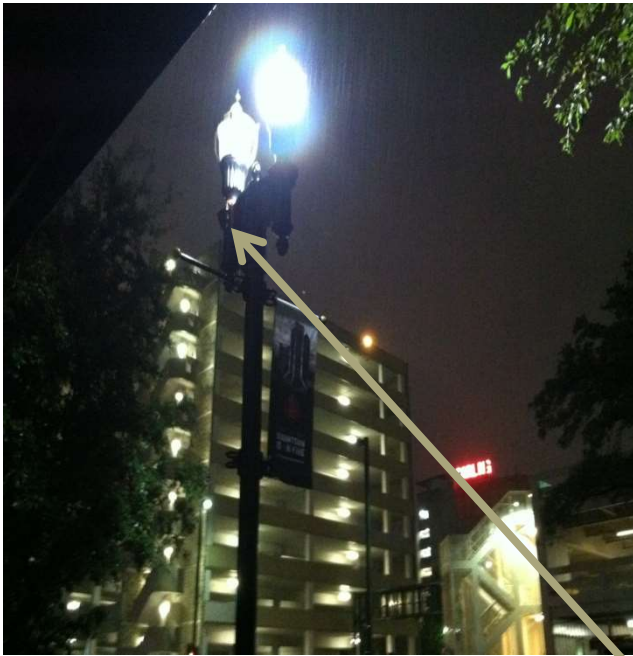
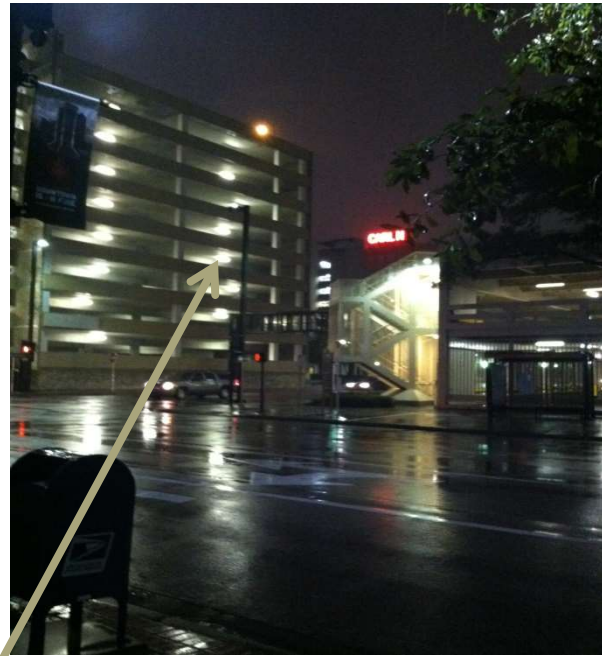
Downtown "Lighting Evaluation" Area "B"

Numerous light fixtures within the evaluated area were found to not be operating.

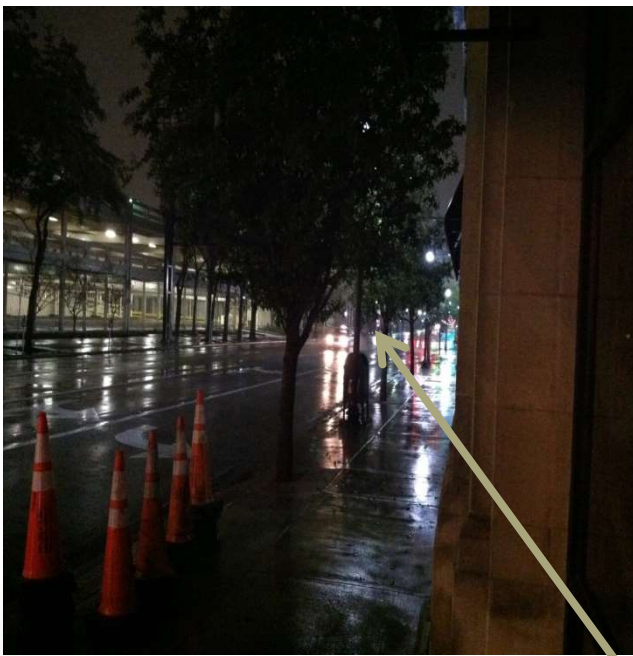
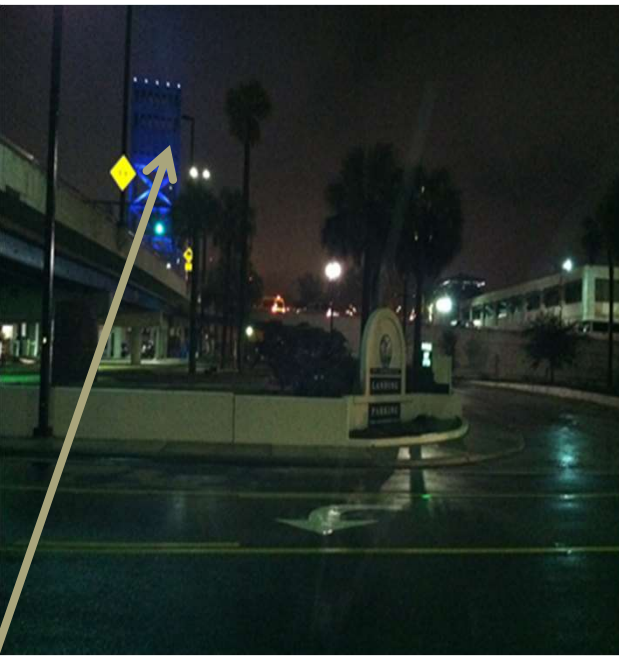
Light fixtures within the evaluated area were found to either be broken (not operational), or obscured by existing landscape. It is recommended that the lights be repaired, and that the tree canopy be trimmed or lower lighting be installed.

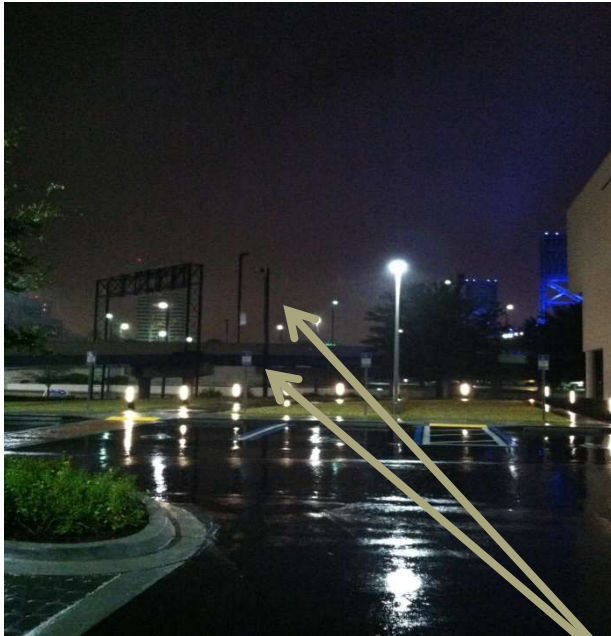
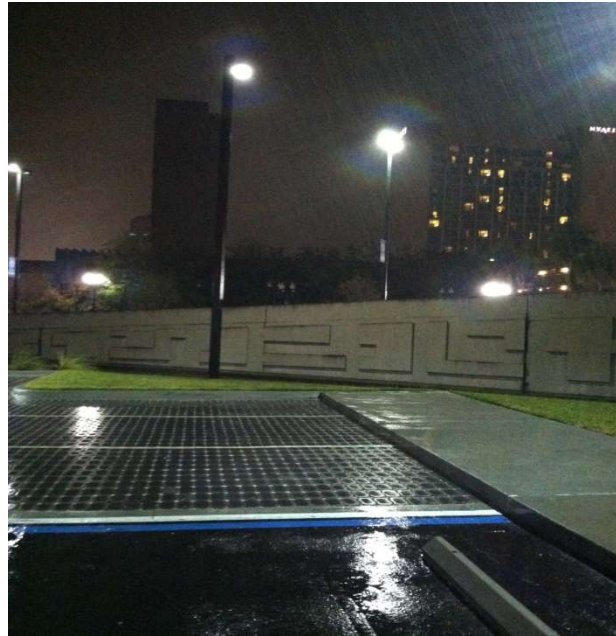
Downtown "Lighting Evaluation" Area "B"

Some areas contained sufficient lighting, and good uniformity, but were still impacted by areas that contained inoperable lights.

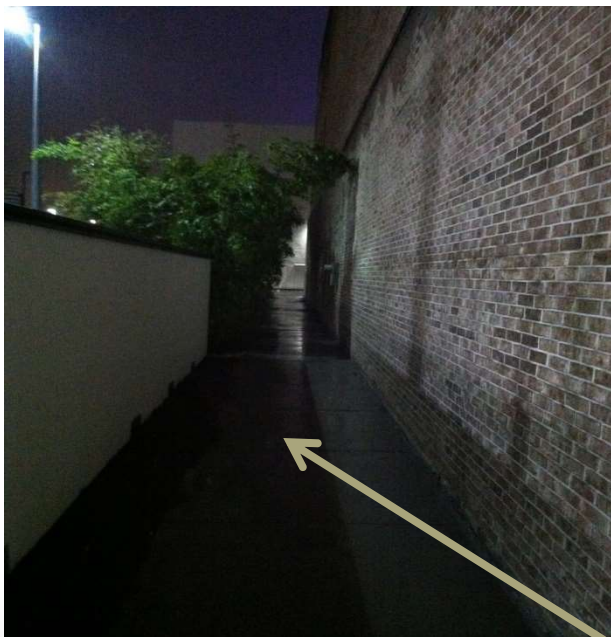
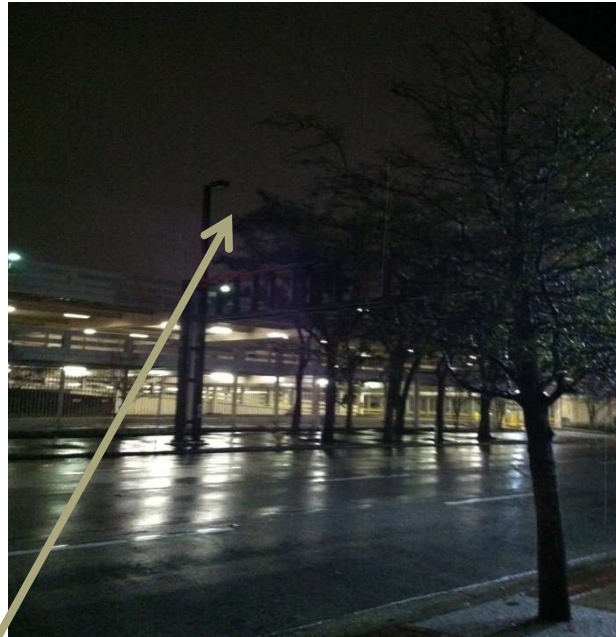
Broken light fixtures, and poorly lit areas contribute to the lack of available surveillance and increase the users fear of crime. It is recommended that either access to these areas be restricted, or additional lighting be placed along the walkway to increase visibility.

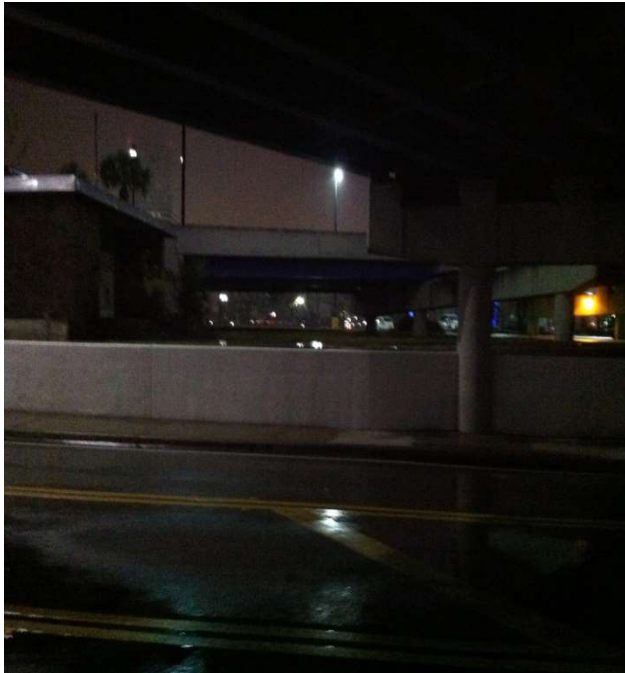
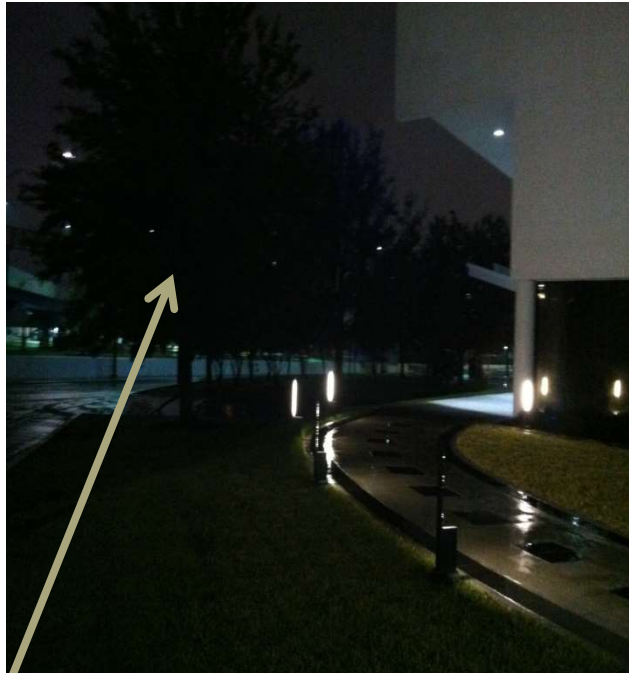
Area "B"

A combination of inoperable lights, tree canopies, and poor design all contribute to the overall lack of lighting and surveillance in the area.

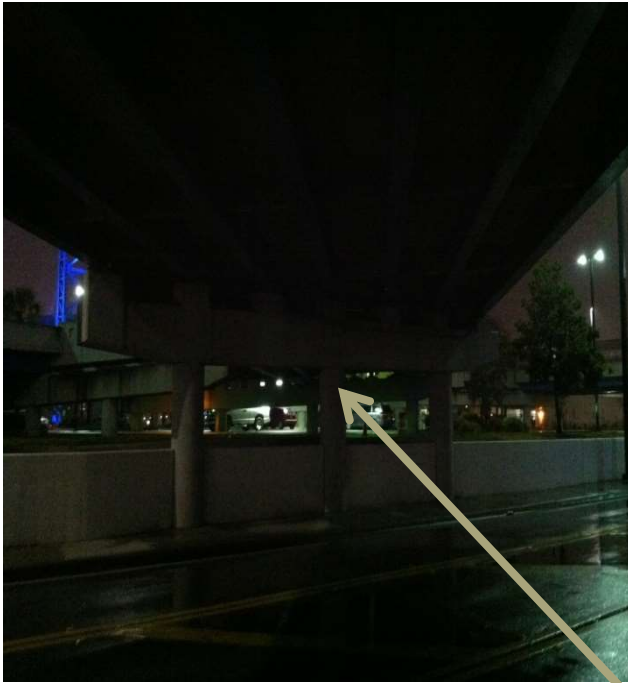
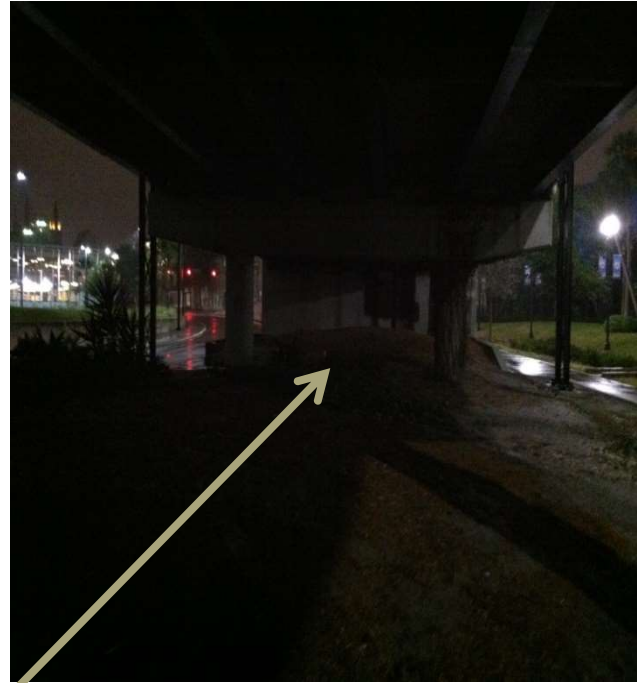
Area "B"

A combination of inoperable lights, tree canopies, and poor design all contribute to the overall lack of lighting and surveillance in the area.

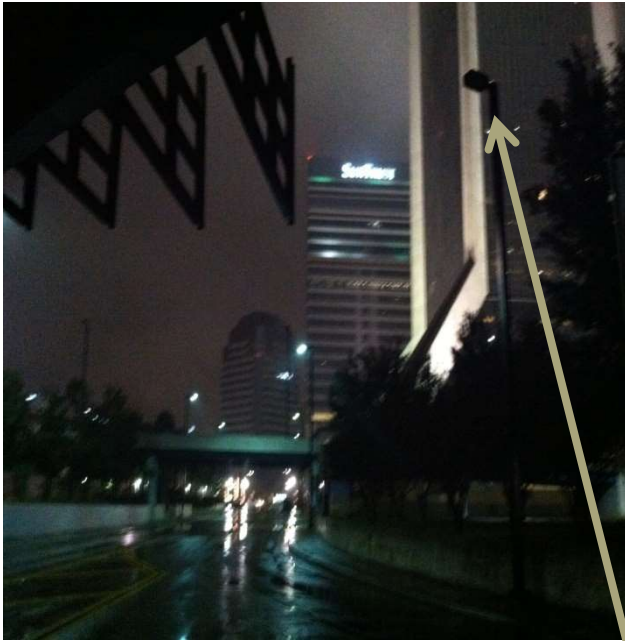
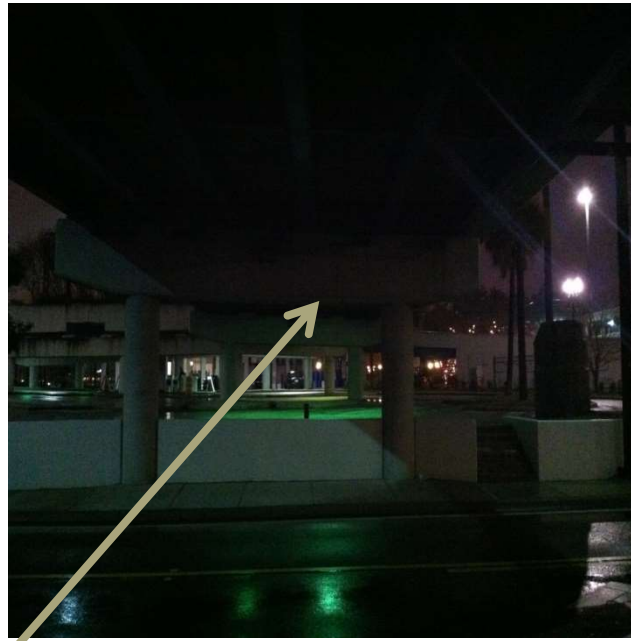
Area "B"

Numerous lights were found inoperable. It is highly recommended that these lights be repaired or replaced
