RESOLUTION 2015-08-02

A RESOLUTION OF THE DOWNTOWN INVESTMENT AUTHORITY (“DIA”) APPROVING A SCOPE OF SERVICES, INCLUDED AS EXHIBIT ‘A’ TO THIS RESOLUTION, FOR THE PROCUREMENT OF PROFESSIONAL SERVICES RELATING TO DOWNTOWN LIGHTING IMPROVEMENTS. AUTHORIZING THE DIA CHIEF EXECUTIVE OFFICER TO NEGOTIATE AND EXECUTE CONTRACTS IN ACCORDANCE WITH THE SCOPE OF SERVICES.

DOWNTOWN LIGHTING STRATEGY AREA REQUEST FOR PROPOSAL

“Downtown Lighting Evaluation”

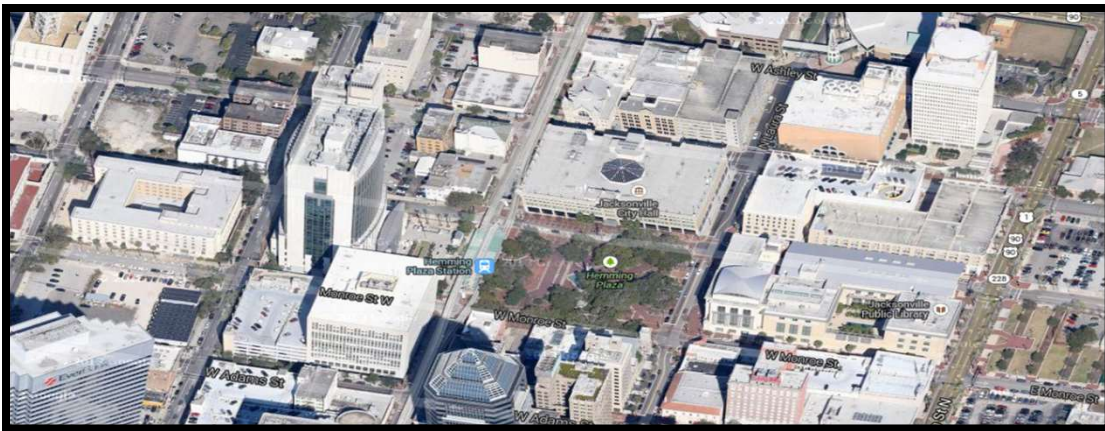
- Area “A” is defined by Laura Street to the East, Duval Street to the North, Monroe Street to the South, and Hogan Street to the West. The area is primarily for recreational (Hemming plaza), and governmental (City Hall / Main Library) use.

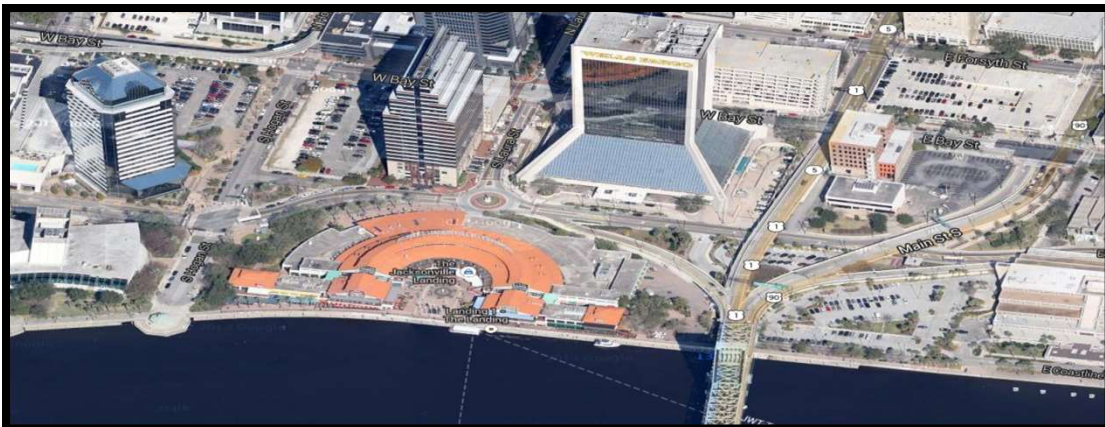
- Area “B” is defined by Bay Street to the North, Independent Drive to the South, Laura Street to the West, and Ocean Street to the East. The area encompasses large scale corporation / commercial, public roadways, and retail / entertainment (Landing).

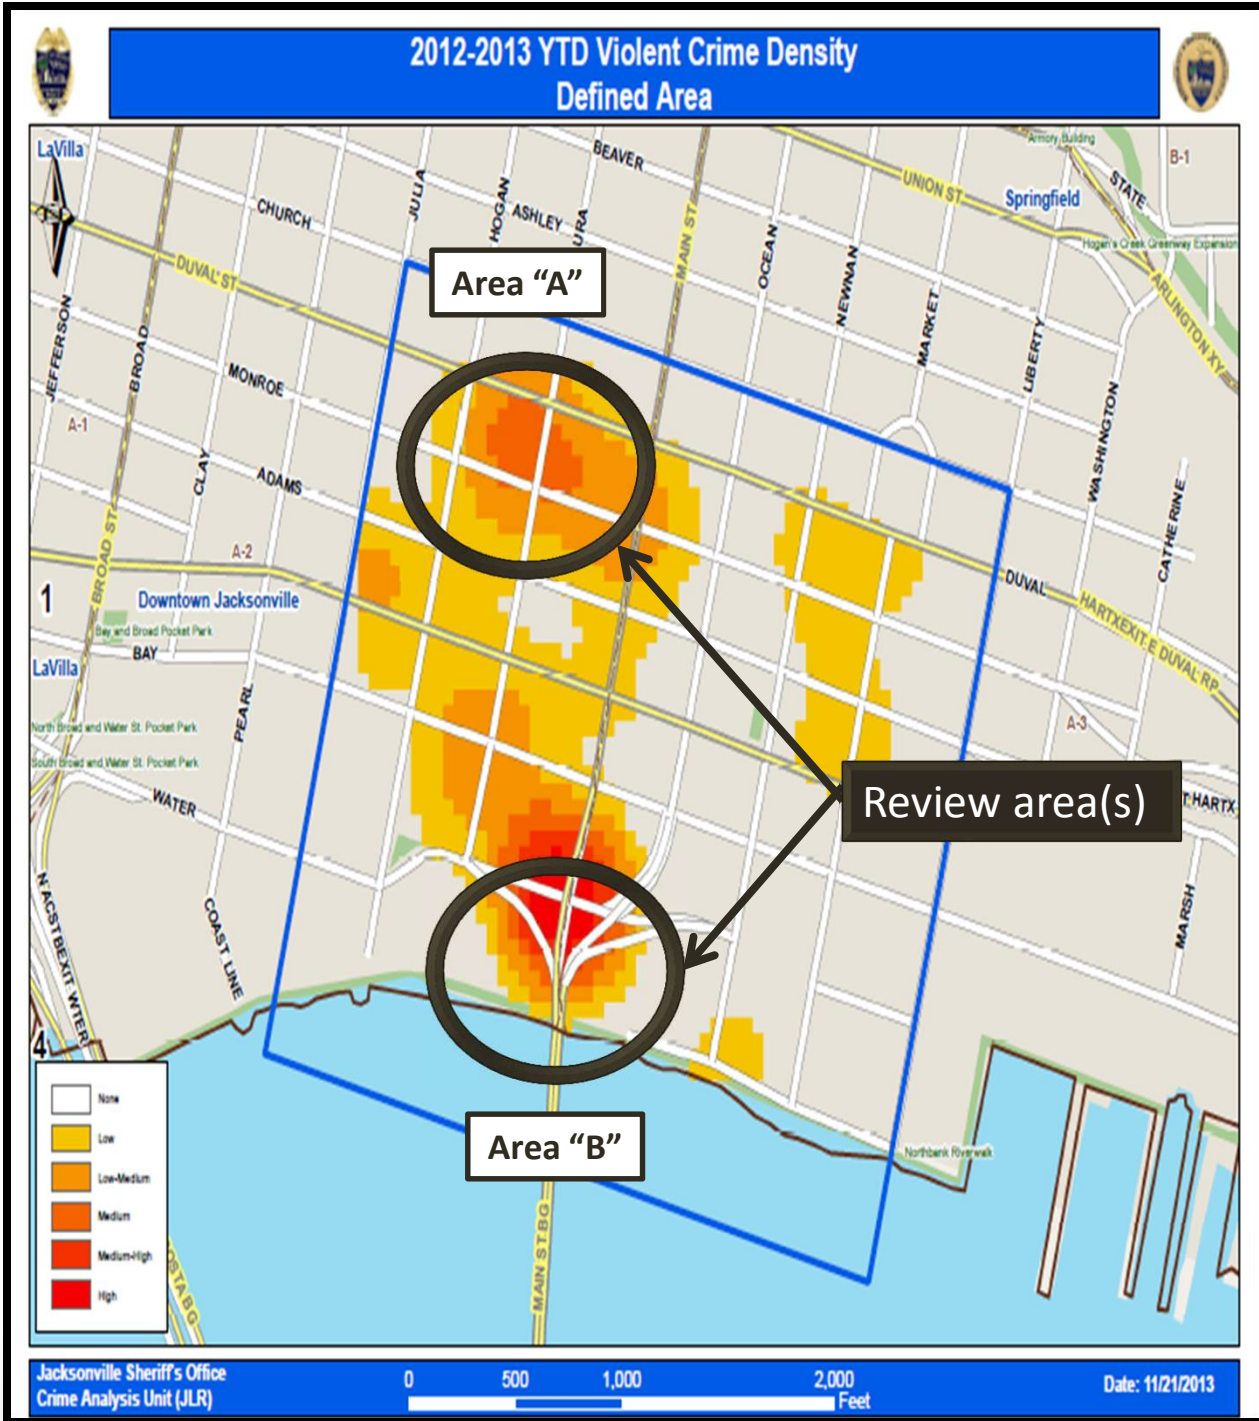
Violent crime area density map is not based on city-wide data, but is an evaluation and comparison of the designated area only.

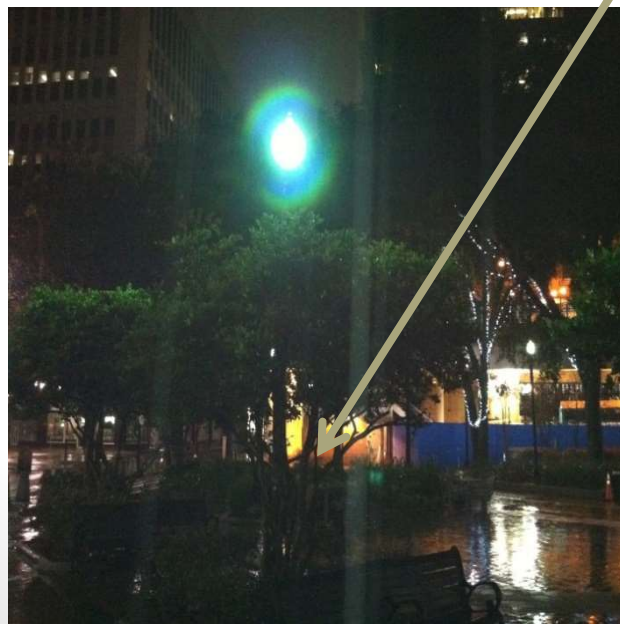
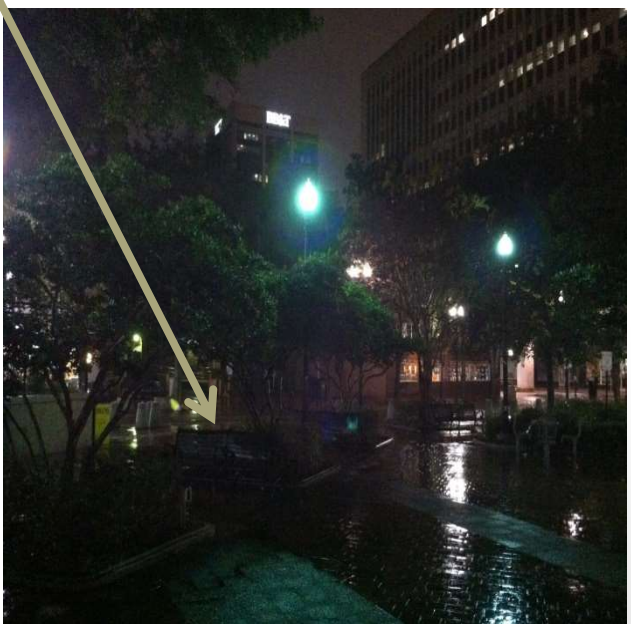
A large number of installed lighting (particularly in the Hemming plaza park area) were either obstructed, or fully concealed by existing vegetation. As a result, numerous concealment areas, and dark locations were created.

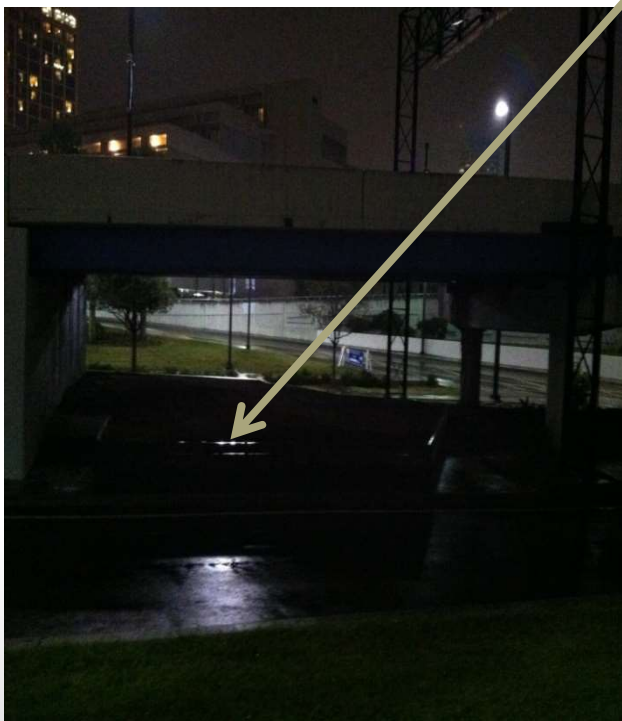
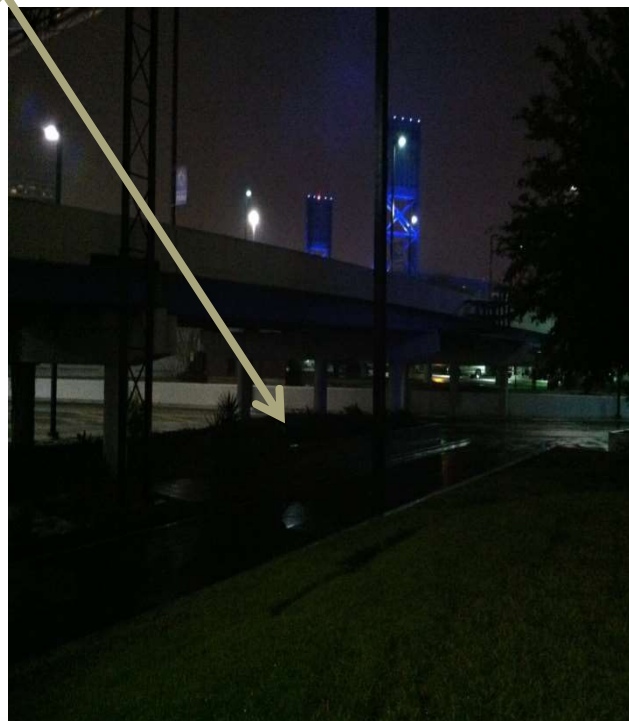
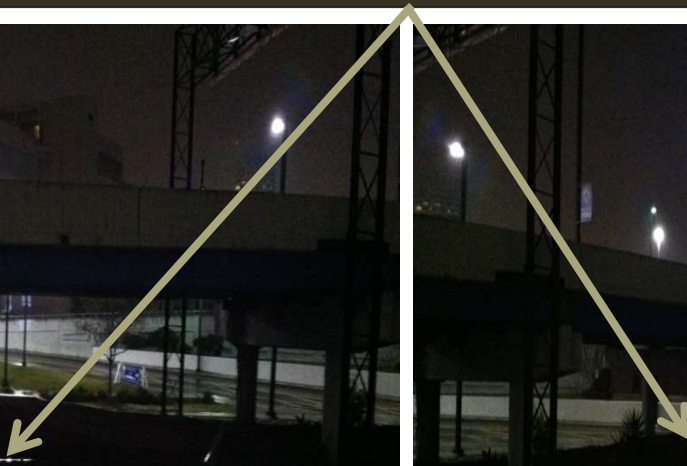
A combination of inoperable lights, tree canopies, and poor design all contribute to the overall lack of lighting and surveillance in the area.

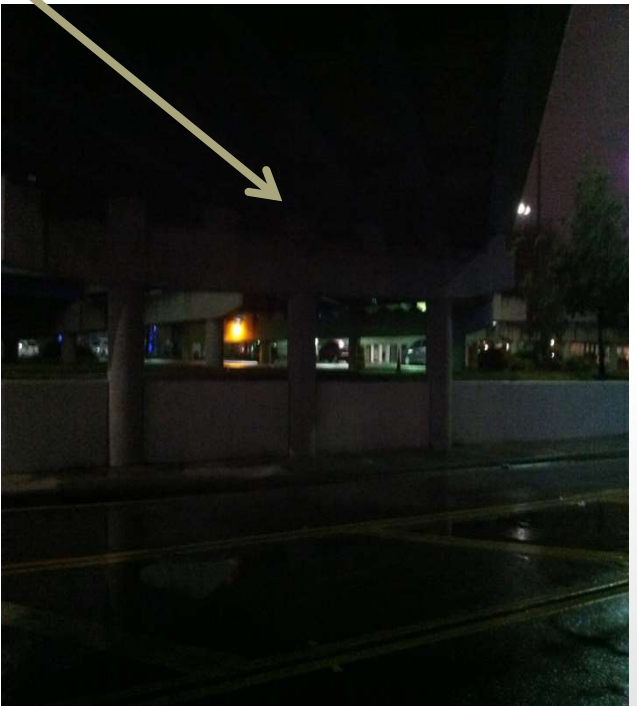
A combination of inoperable lights, tree canopies, and poor design all contribute to the overall lack of lighting and surveillance in the area.

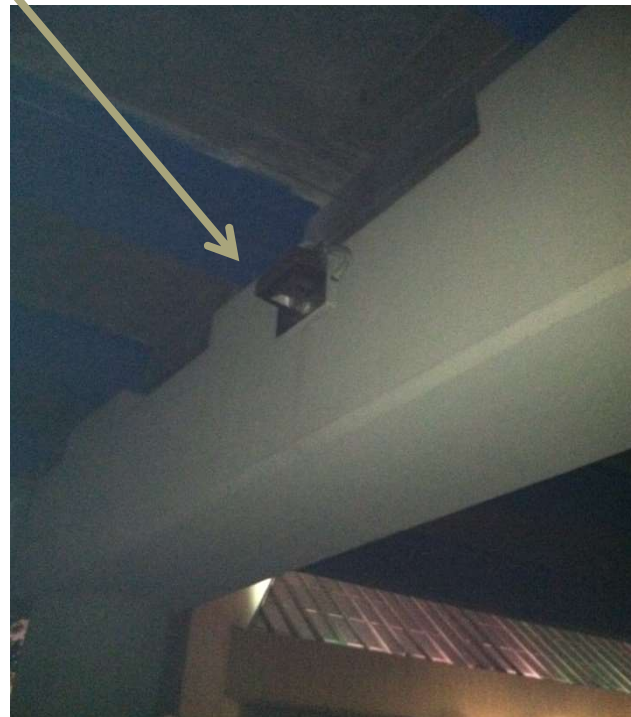
Numerous lights were found inoperable. It is highly recommended that these lights be repaired or replaced
